Intercomparison of Condensation Particle Counter

Project No.: CPC-2015-1-1

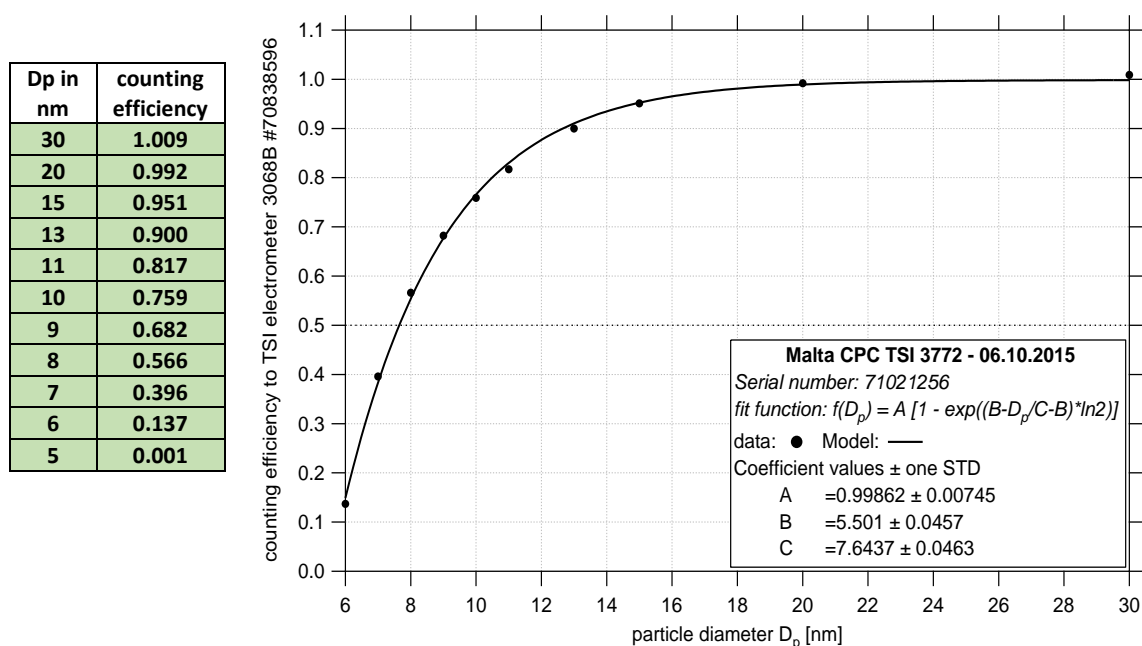
Pre-status: 06.10.2015, Tuesday

The TSI CPC 3772 was in good condition. After 2 weeks, the CPC 3772 was broken. Repair by TSI was necessary.

Figure 01: CPC efficiency curve. Based on Electrometer TSI 3068B. Serial number: 70838596

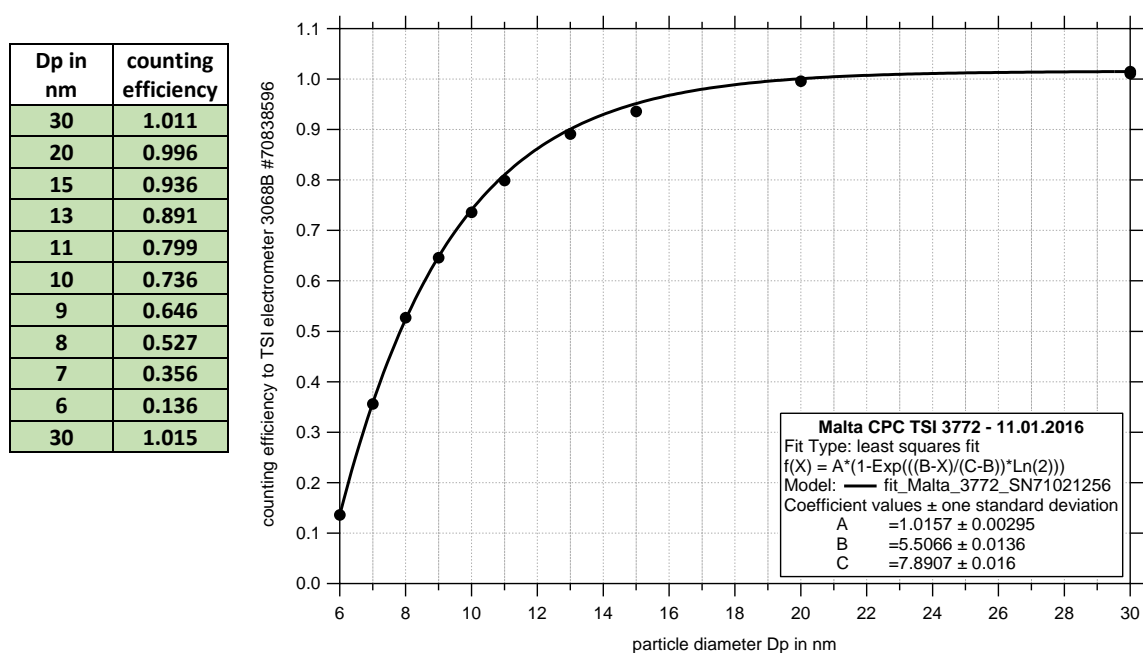
final-status: 11.01.2016, Monday

1. Status of the wick: The wick was cleaned, because it was dirty.
2. Status of the CPC: The CPC was not working properly. It was necessary to send it to TSI for repair.
3. Final CPC-Workshop: The CPC 3772 reached 100% efficiency at 30 nm. The Dp50 is at 7.9 nm. The CPC efficiency curve corresponds to the standard.

Figure 02: CPC efficiency curve. Based on Electrometer TSI 3068B. Serial number: 70838596
