Audit/Twinning Report

Station name: Danum Valley
Date: November 26 -30 2017
Auditor: Dr. Thomas Tuch (WMO-GAW-WCCAP, TROPOS)
Responsible station staff: Maznorizan Bt Mohamad, Mohan Kumar A/L Sammathuria

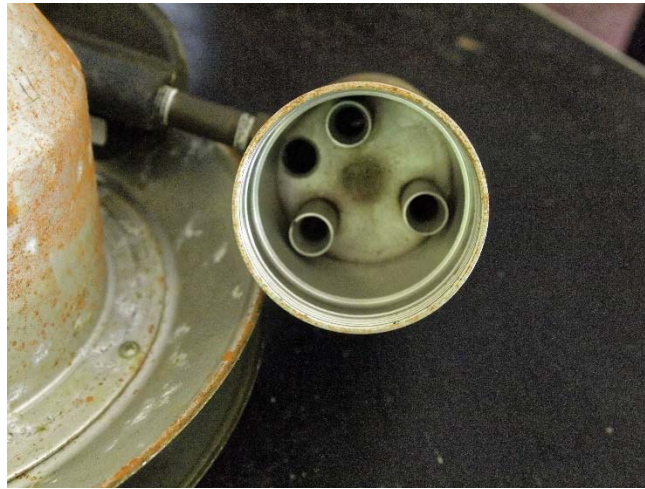
The aerosol inlet at Danum Valley has been designed at TROPOS. It features two custom made Nafion dryers. The PM10 inlet head was found to be relatively clean inside (Figure 2).

Figure 2: PM10 inlet at Danum Valley

The exterior of the inlet has been cleaned during the audit.

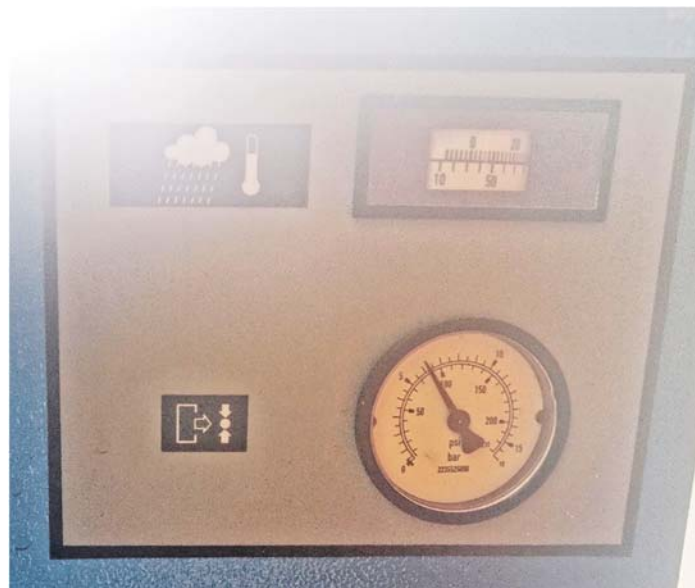
The compressor providing dry air to the Nafion dryers is in good working condition. It reaches a compressed air dew point temperature of 7 deg. C (Figure 3).

Figure 3: Status of the compressor at Danum Valley.

The secondary dryer (Boge DAZ 5-2) is broken. This dryer provides dry air to the Nafion dryers at a compressed air dew point temperature of less than -20 deg. C. This dryer has reached the end of its typical lifetime. Spare parts for repair would cost about the same as a new device.

The secondary dryer was bypassed during the audit. Furthermore, the compressed air flow to the Nafion dryers was increased from 1 l/min to 16 l/min. With these changes, the humidity of the aerosol could be reduced to about 45% rH. GAW recommendations require an aerosol rH below 40%.

Recommendation: Replace the secondary (<https://www.boge.com/en/products/adsorption-dryers-heatless-regeneration>) dryer by a new device.

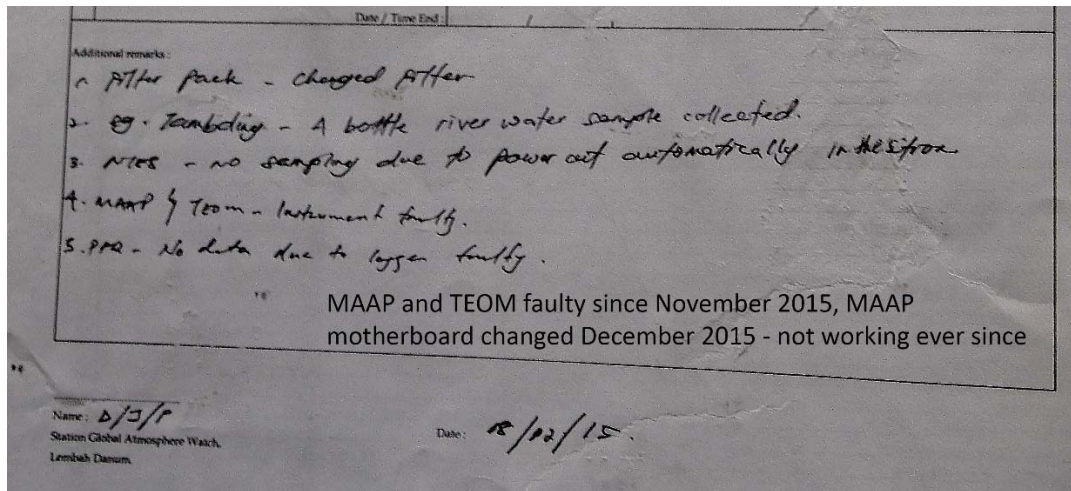
MAAP and TEOM faulty since November 2015, MAAP motherboard changed December 2015 - not working ever since

Figure 4: MAAP failure notice in the logbook.

After replacement of the motherboard of the instrument, the display of the unit did only show erroneous characters. Communication over the serial port of the instrument was not possible. A new display unit has been ordered but did never arrive at the station. We discovered during the audit that the failure of the instrument is not only due to the display but also obviously again to a broken motherboard. The serial port chip of the motherboard driving both the serial I/O and the display was extremely hot and showed some color change. It seems that there is more than one component of the instrument broken. The instrument should be repaired by the manufacturer due to multiple instrument problems.

MAAP data are unusable/non-existent after November 2015.

Recommendation: Send the MAAP to the manufacturer for factory repair.

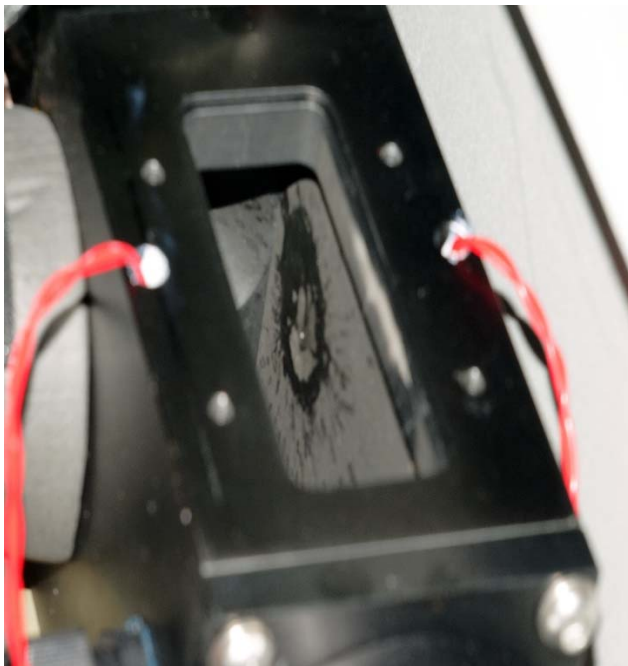
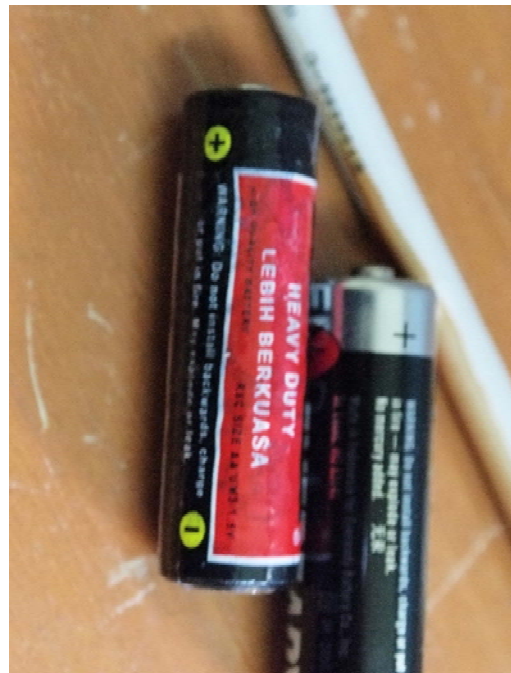
With the instrument open we found the measurement cell heavily polluted. Furthermore the backup batteries have not been replaced for several years. These batteries should be replaced at least once per year to avoid damage to the instrument (Figure 6).

Figure 6: Dirty measurement cell and broken backup batteries of the Nephelometer.

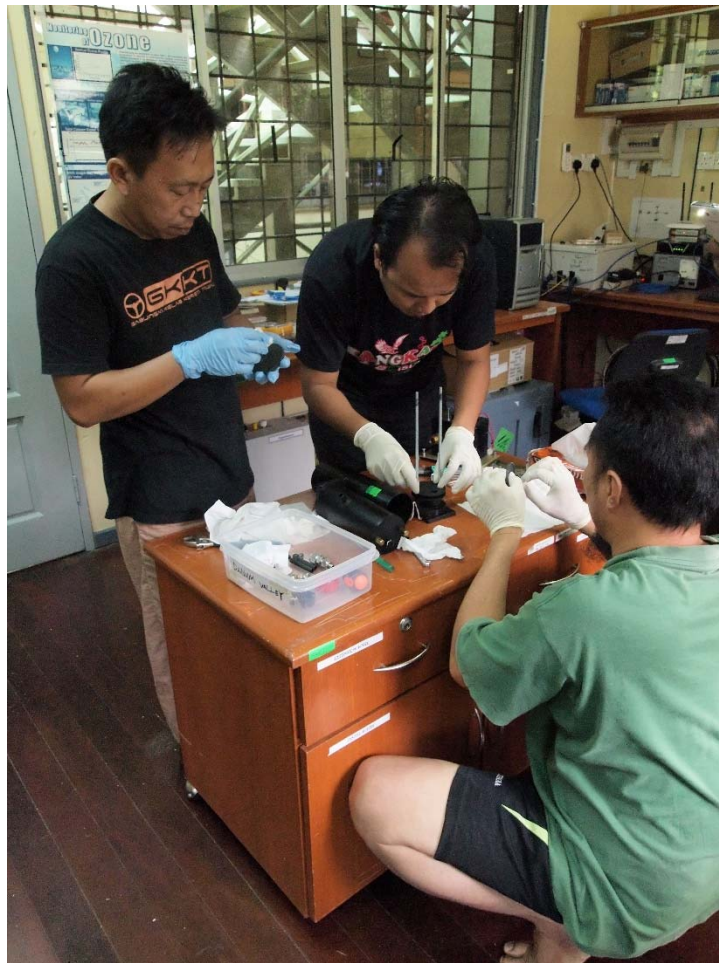
The Nephelometer measurement cell was cleaned by the station staff during the audit. Cleaning of the measurement cell should be performed at least once per year or whenever wall scatter signals increase significantly. (Figure 7)

Figure 7: Nephelometer cleaning.

- 1) The Nephelometer cell should be checked and cleaned (if necessary) on an annual basis.
- 2) The backscatter shutter needs to be repaired by the manufacturer.

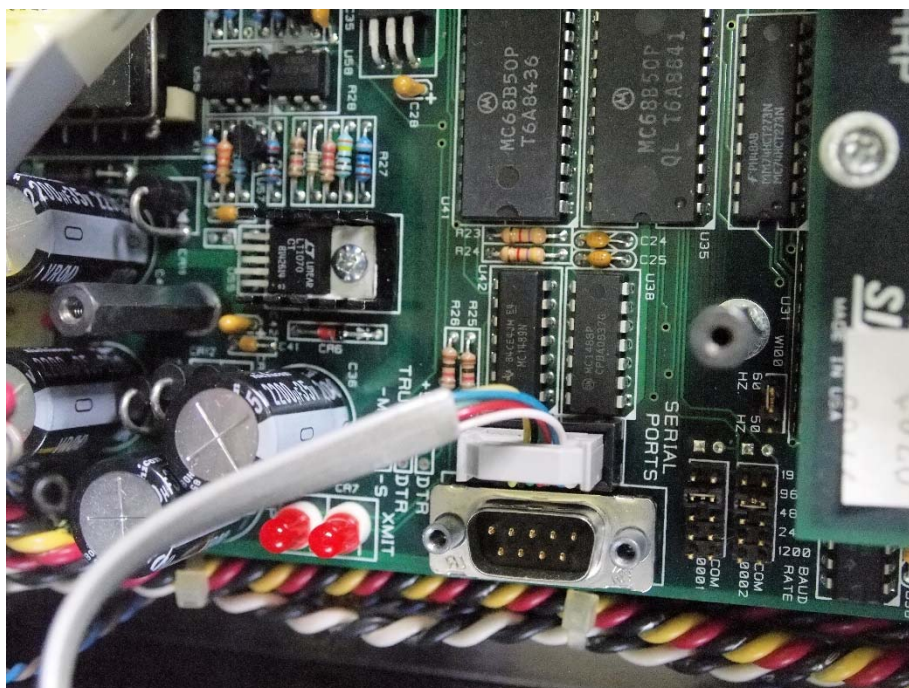
The TEOM SN 140AB214609703 was running upon arrival at the station. Data communication was, however, again not possible due to a problem with the serial port of the instrument. This failure was first observed in July 2017. The motherboard of the TEOM control unit was replaced by an existing spare part during the audit (Figure 8).

Figure 8: TEOM motherboard with internal serial connector.

After change of the motherboard, the instrument was able to communicate via serial port. With this board heating of the TEOM sensor unit did not work. The instrument could therefore not stabilize into measurement mode.

There are spare TEOM control units available at the headquarters in Kuala Lumpur. One of these units should replace the broken control unit at Danum Valley. Note that all operation parameters need to be transferred from the broken instrument to the replacement unit.

Recommendation: The broken control unit should be replaced by a spare control from Kuala Lumpur.
