Intercomparison of Mobility Particle Size Spectrometers

Project No.: MPSS-2015-1-1

Basic information:

Summary of Intercomparison:

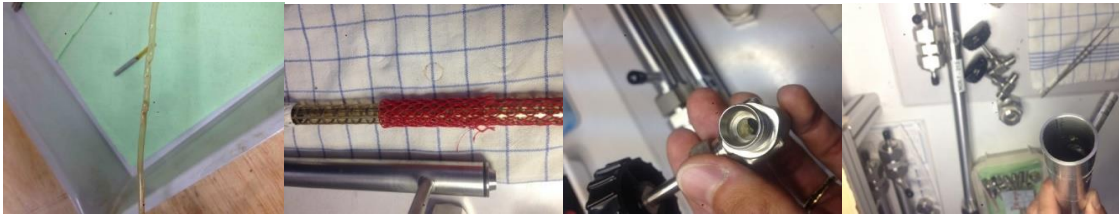
Figure 01: Status of the nafion membrane. The nafion membrane is completely damaged from the sea salt and it is also broken in two pieces.

- The Malta TROPOS-MPSS was completely disassembled. Therefore, an initial status check was not possible.
- shipped without radioactive source → during the workshop we used a TSI-Kr85 source from TROPOS
- CPC-Workshop: The CPC 3772 reached 100% efficiency at 30 nm. The Dp50 is at 7.6 nm. The CPC efficiency curve corresponds to the standard.
- All Nafion dryers (ND.07-66, ND.07-67, ND.07-68, MD-110-12E-S 1610210-7) were in a bad condition, because of contamination by sea salt. All of them have to be replaced with new ones.

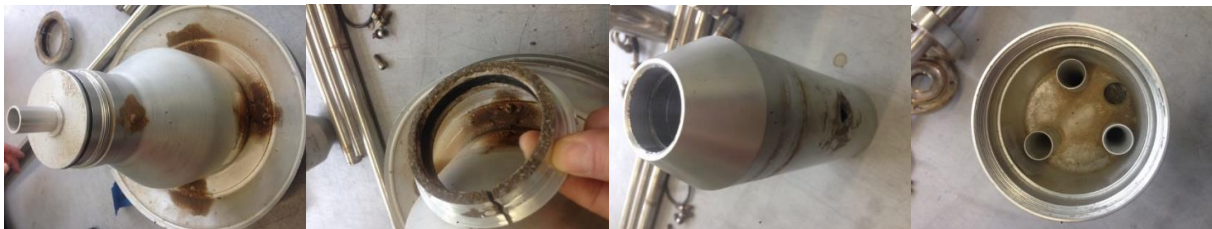
Figure 02: Status of the PM10 head. There was heavy corrosion on the supporting screws and ring. Screws and aluminium net were replaced.

- The whole aerosol inlet (head, inlet, splitter) have been delivered to the electronic and mechanic workshop. The PM10 head and splitter were cleaned. All tubes and fittings were replaced by new ones.

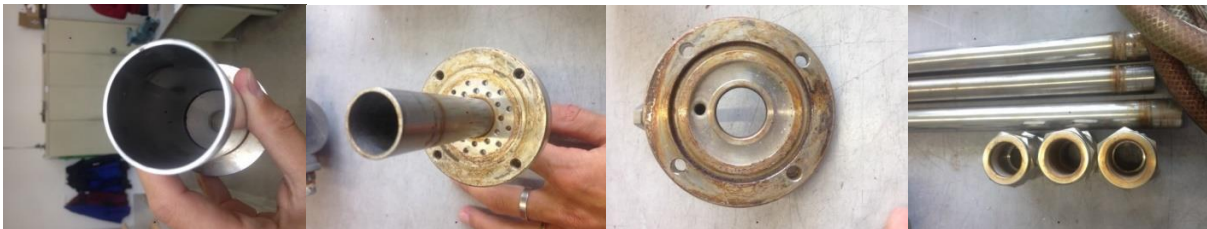
Figure 03: Splitter and SS piping. The splitter was sand blasted and the piping and fitting were replaced.

- Before mounting the whole Malta TROPOS-MPSS back, each part of the rack and fittings were cleaned and checked. Both the electronic box and the A/C unit have been inspected by the electronic group to make sure that everything is in proper order. All the aerosol lines have been wet cleaned in a sonic bath with a water based

solution (distilled water + isopropanol + commercial surfactant), rinsed with distilled water and dried by means of compressed air. All the nylon ferrules were replaced with new ones in the mounting phase.

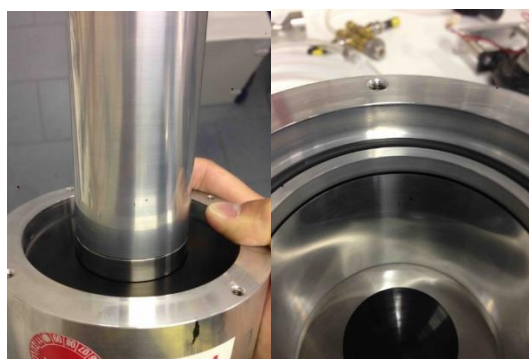
- The DMA has been opened and inspected. A visible passivation layer has been observed in the negative electrode, as well as on the positive one. This thin corrosion layer is due to the salty environment in which the system is working. The mechanical workshop cleaned the DMA, mechanically removing the passivation layer from the electrodes.

Figure 04: DMA status: The DMA was opened and completely cleaned.

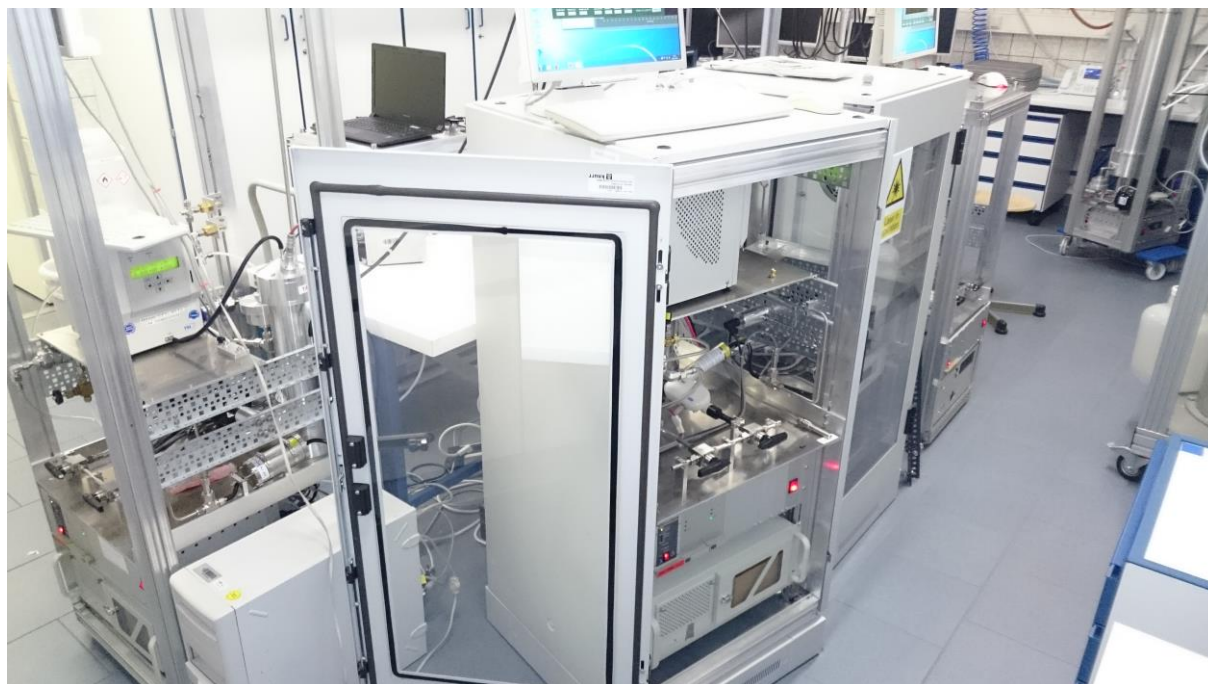
Figure 05: Setup of the Malta TROPOS-MPSS in the TROPOS lab 118.

- The Malta TROPOS-MPSS was calibrated: High voltage and PSL with Latex 203 nm.
- Discussion with the provider about the setup in the future: The whole inlet has been revised, to optimize the aerosol lengths for each instrument and, as much as possible, protect all the components against sea salt. This is realized by implementing a PM1 before the main nafion dryer, MPSS, MAAP. The OPSS is operating after the PM10 head together with a nafion dryer. The whole Malta setup complies with the standards of ACTRIS and GAW.

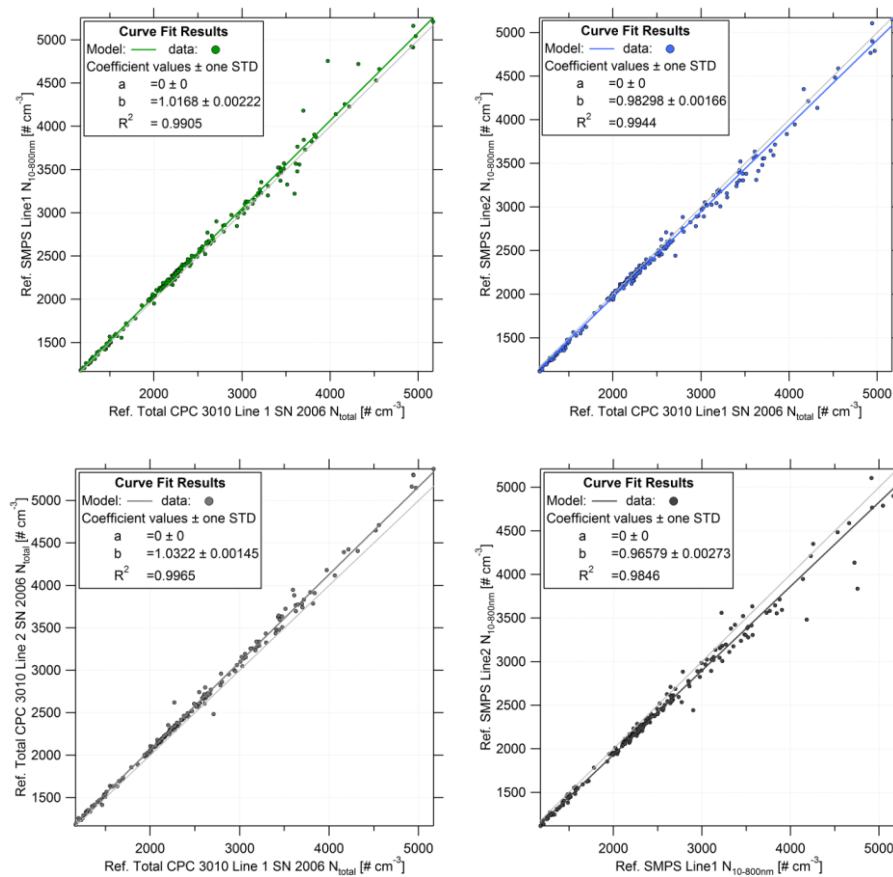
Figure 06: Correlations of the TROPOS Reference MPSS systems and the Reference TSI CPCs Model 3010 of both lines (see laboratory setup). Multiple charge, internal diffusion loss and CPC flow corrections are included.

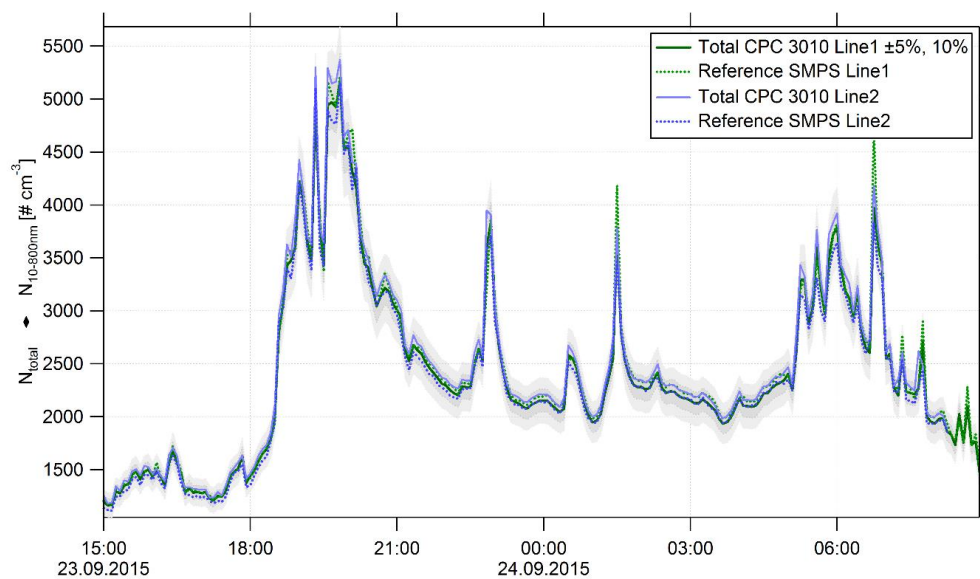
Figure 07: Intercomparison between the two Lines. For each Line there is a TROPOS Reference MPSS and a Reference TSI CPC Model 3010, which are calibrated against an electrometer. Multiple charge, internal diffusion loss and CPC flow corrections are included.

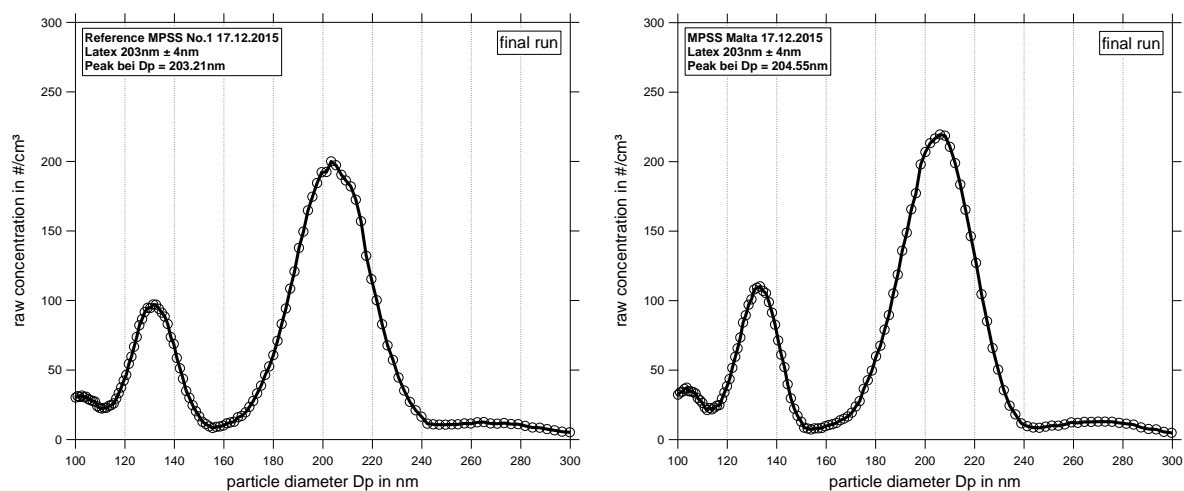
Figure 08: Measurement of latex 203 nm: Particle size distribution (raw concentration) for latex 203 nm on December 17, 2015.

Institut	System		Latex 203 [nm]	slope
TROPOS	Reference MPSS No.1	Pre-status		
		final	203.0	4.89
UOM	MPSS Malta	Pre-status	-	-
		final	203.0	4.95

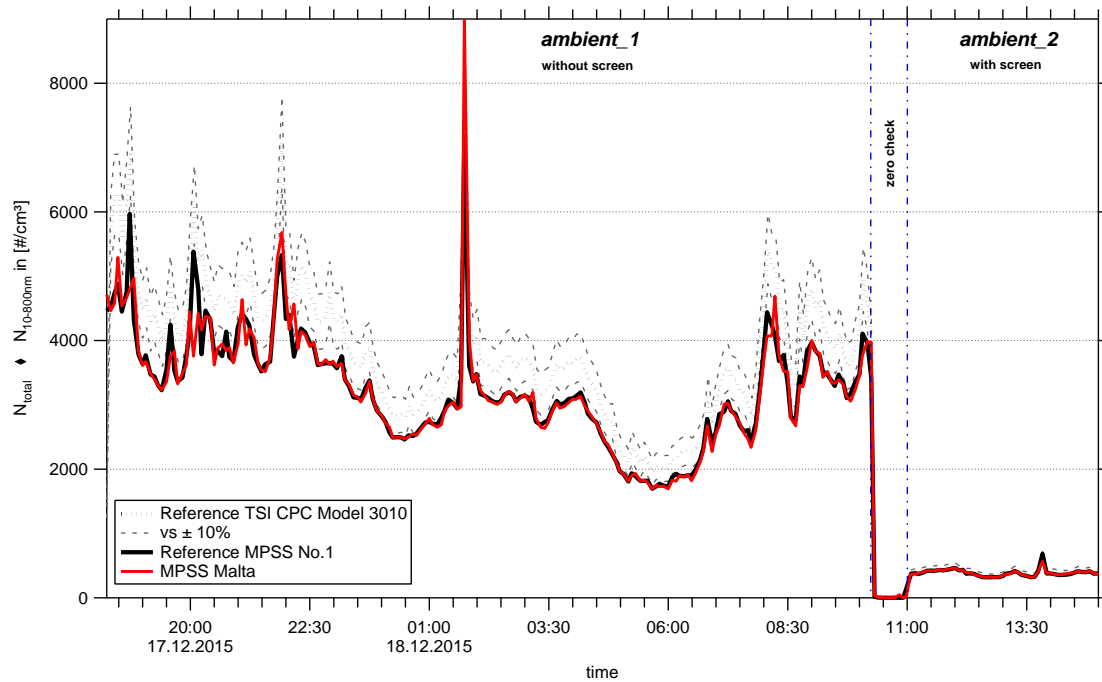
Figure 9: Time series (December 17, 2015 18:00 pm – December 18, 2015 15:00 pm) of the integrated particle number concentration ($N_{10-800nm}$) of the MPSS and total number concentration (N_{total}) of the reference TSI-CPC Model 3010. The inversion was performed using TROPOS software. Multiple charge correction, internal diffusion losses and CPC flow corrections are included.

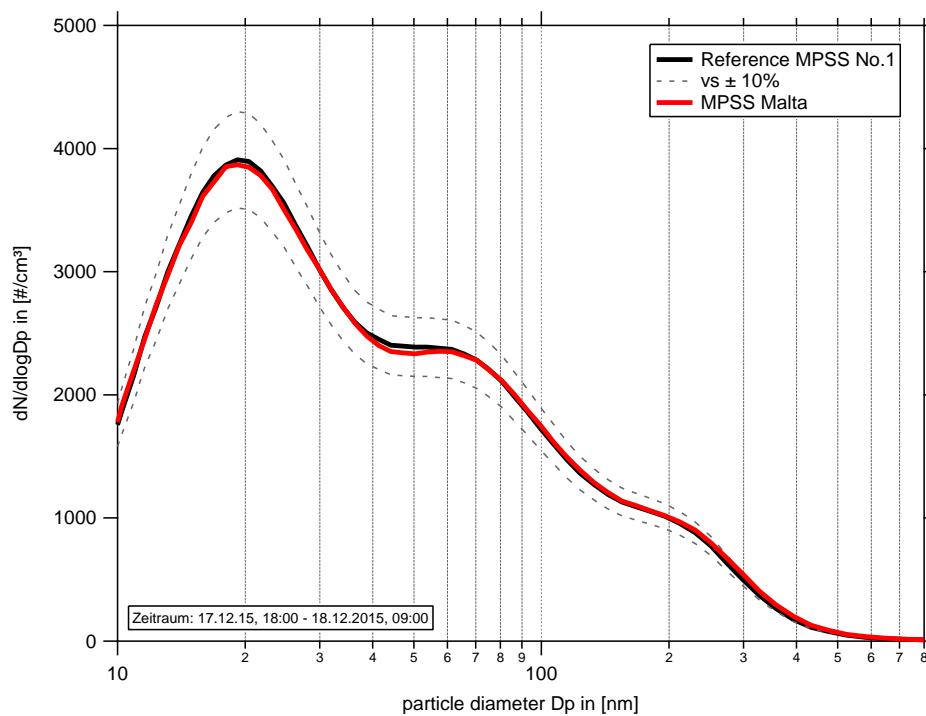
Figure 10: Comparison of mean particle number size distribution of Malta TROPOS-MPSS and TROPOS reference instrument No.1 from December 17, 2015 18:00 pm until December 18, 2015 09:00 am. The inversion was performed using TROPOS software. Multiple charge correction, internal diffusion losses and CPC efficiency are included.

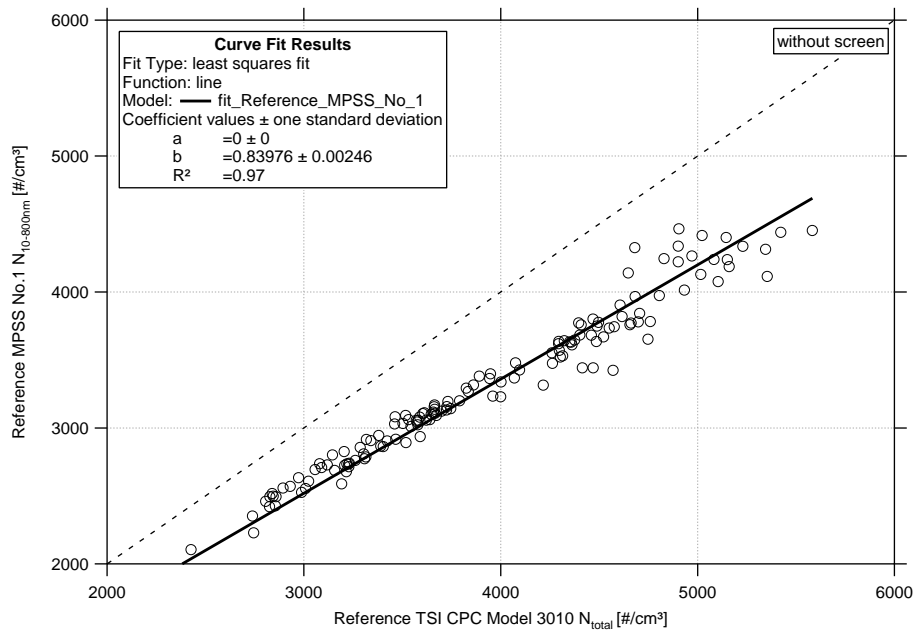
Figure 11: Linear regression between the number concentrations of the TROPOS Reference MPSS No.1 and TROPOS Reference TSI CPC Model 3010. Multiple charge correction, internal diffusion losses and CPC flow corrections are included.

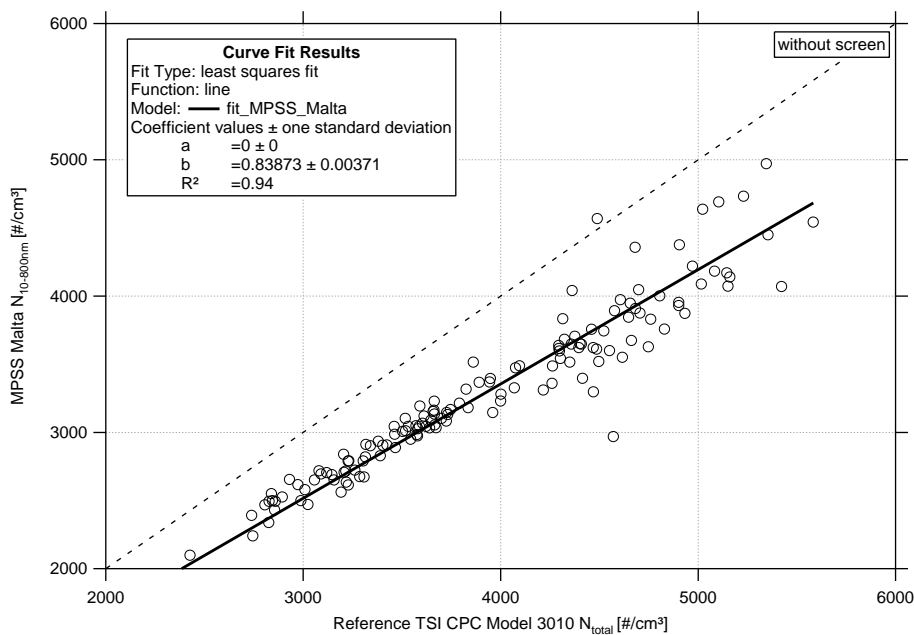
Figure 12: Linear regression between the number concentrations of the MPSS Malta and TROPOS Reference TSI CPC Model 3010. Multiple charge correction, internal diffusion losses and CPC flow corrections are included.

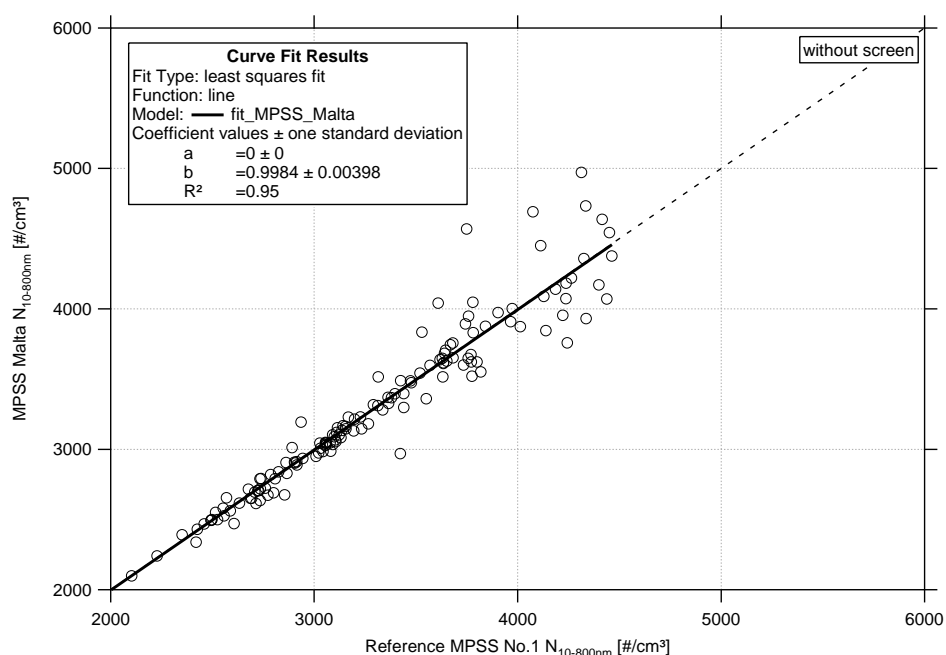
Figure 13: Linear regression between the number concentrations of the MPSS Malta and TROPOS Reference MPSS No.1. Multiple charge correction, internal diffusion losses and CPC flow corrections are included.

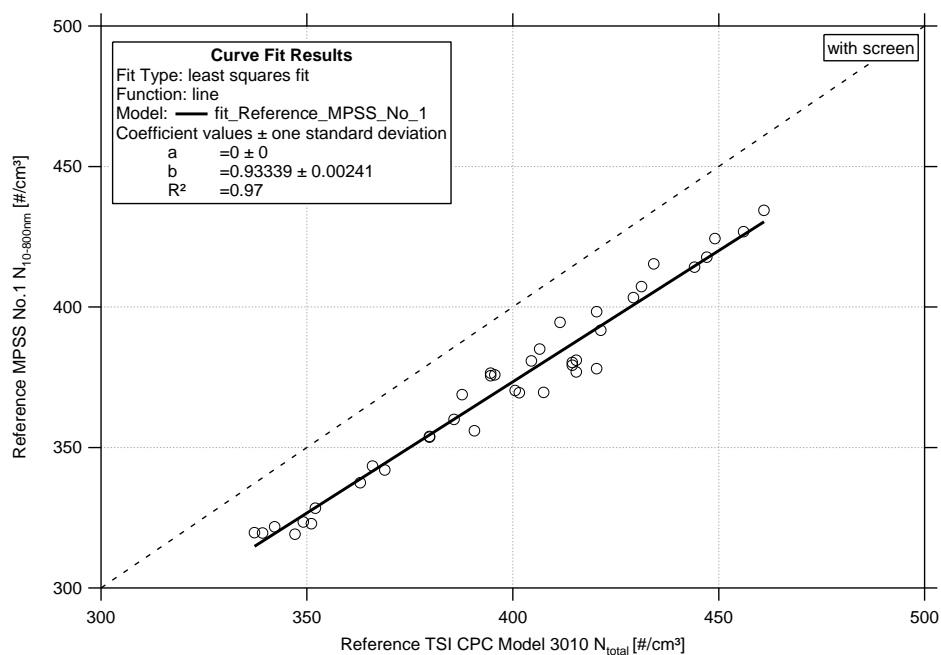
Figure 14: Linear regression between the number concentrations of the TROPOS Reference MPSS No.1 and TROPOS Reference TSI CPC Model 3010. Multiple charge correction, internal diffusion losses and CPC flow corrections are included.

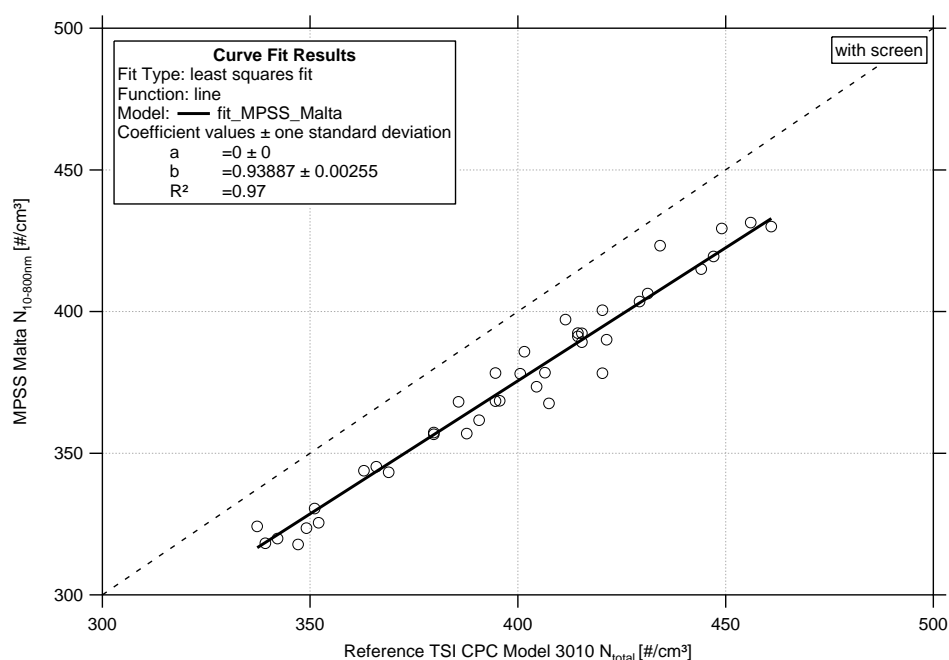
Figure 15: Linear regression between the number concentrations of the MPSS Malta and TROPOS Reference TSI CPC Model 3010. Multiple charge correction, internal diffusion losses and CPC flow corrections are included.

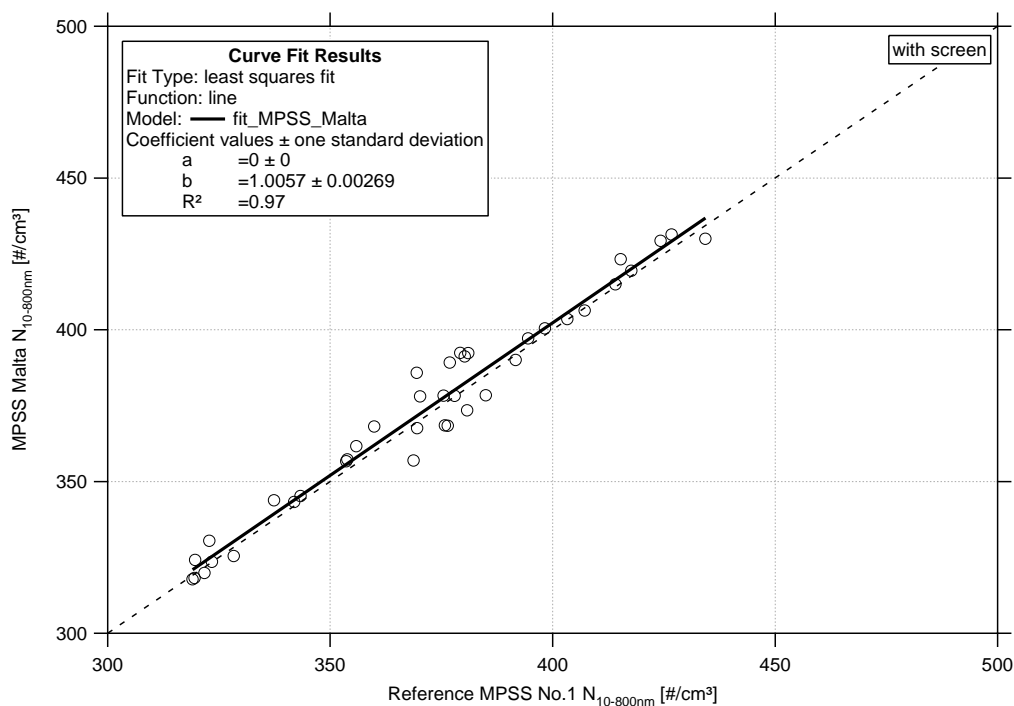
Figure 16: Linear regression between the number concentrations of the MPSS Malta and TROPOS Reference MPSS No.1. Multiple charge correction, internal diffusion losses and CPC flow corrections are included.
